EWP Streambank Protection at East Brook Hillside Stabilization
Before and After Photos

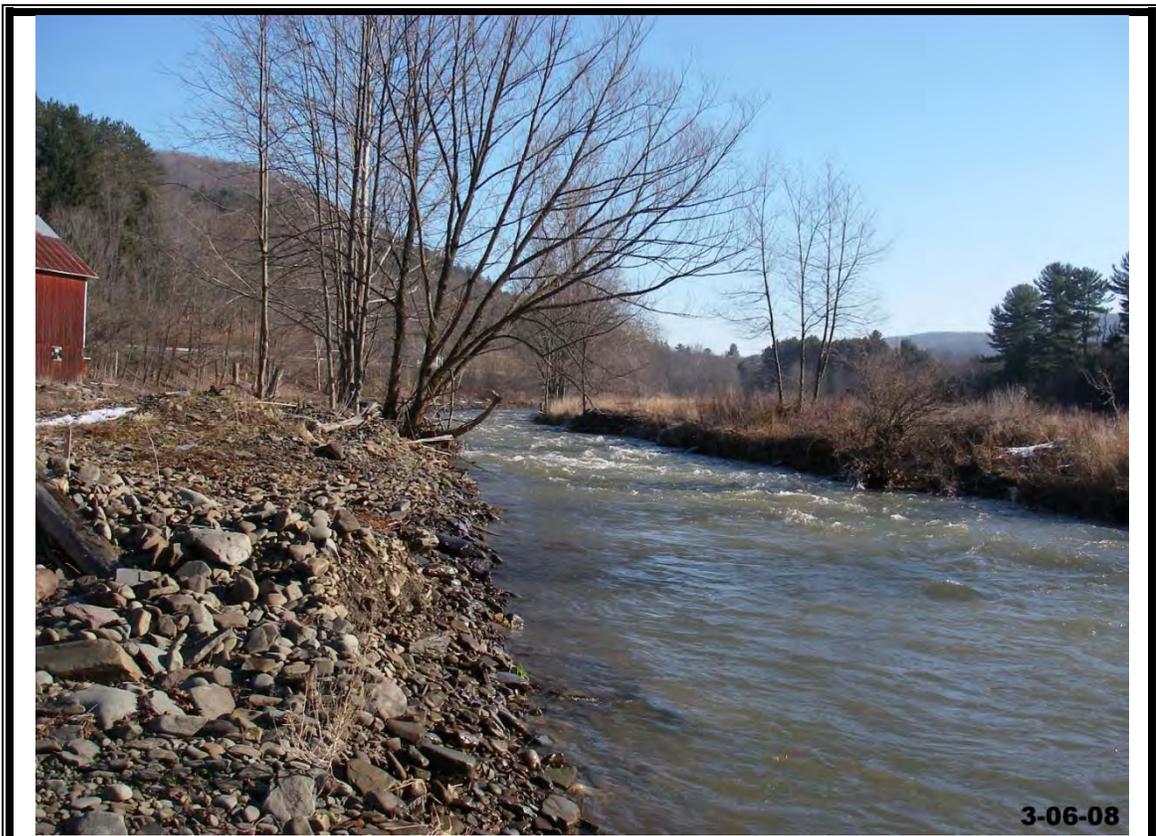
Photo 1: Looking downstream from right streambank at upper portion of project area.

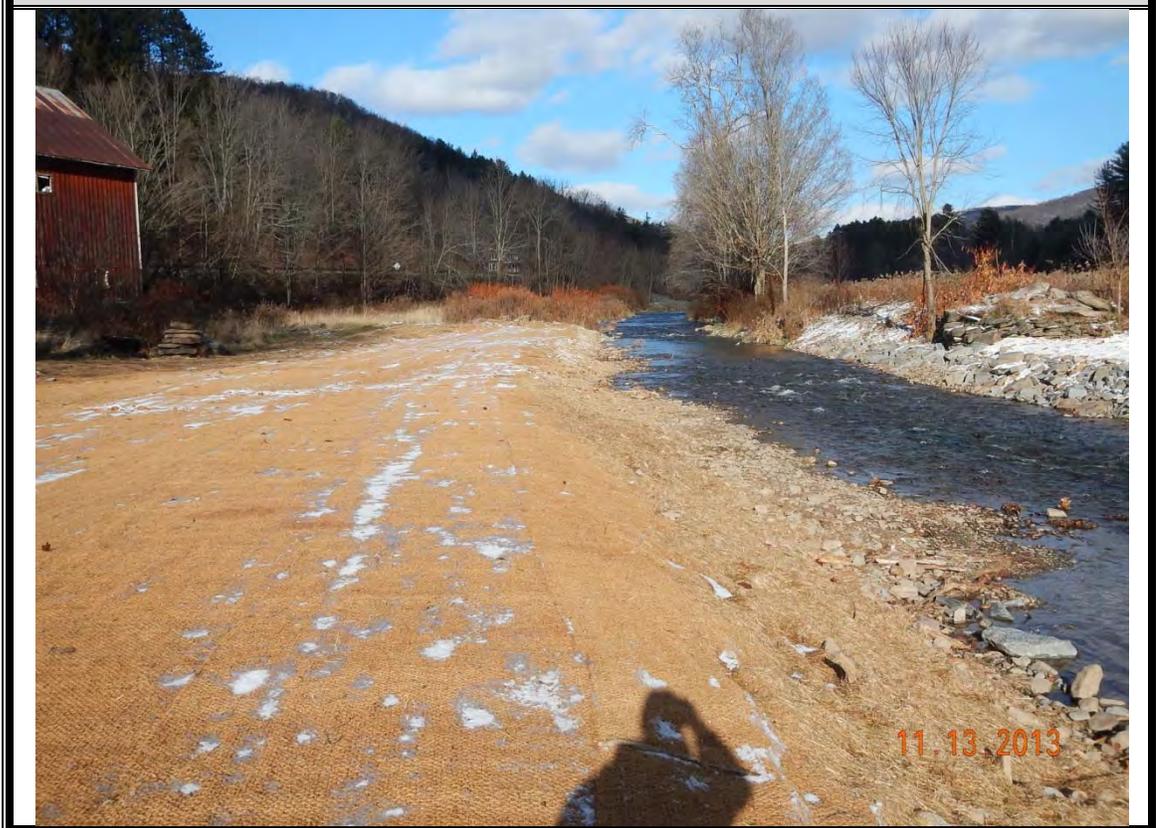
Photo 2: Looking upstream from right streambank at upper portion of project area after construction at right floodplain and hardened rock riffle structure.

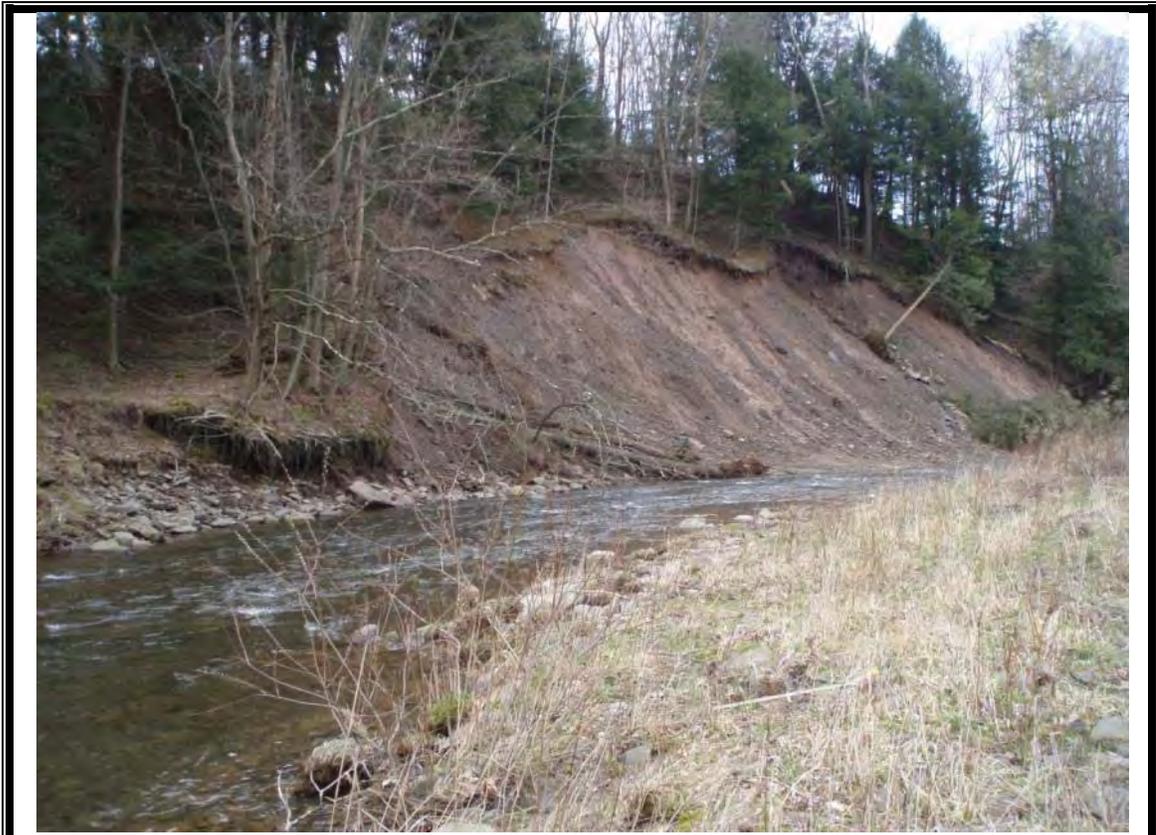
Photo 3: Looking downstream from right streambank at left eroding streambank.

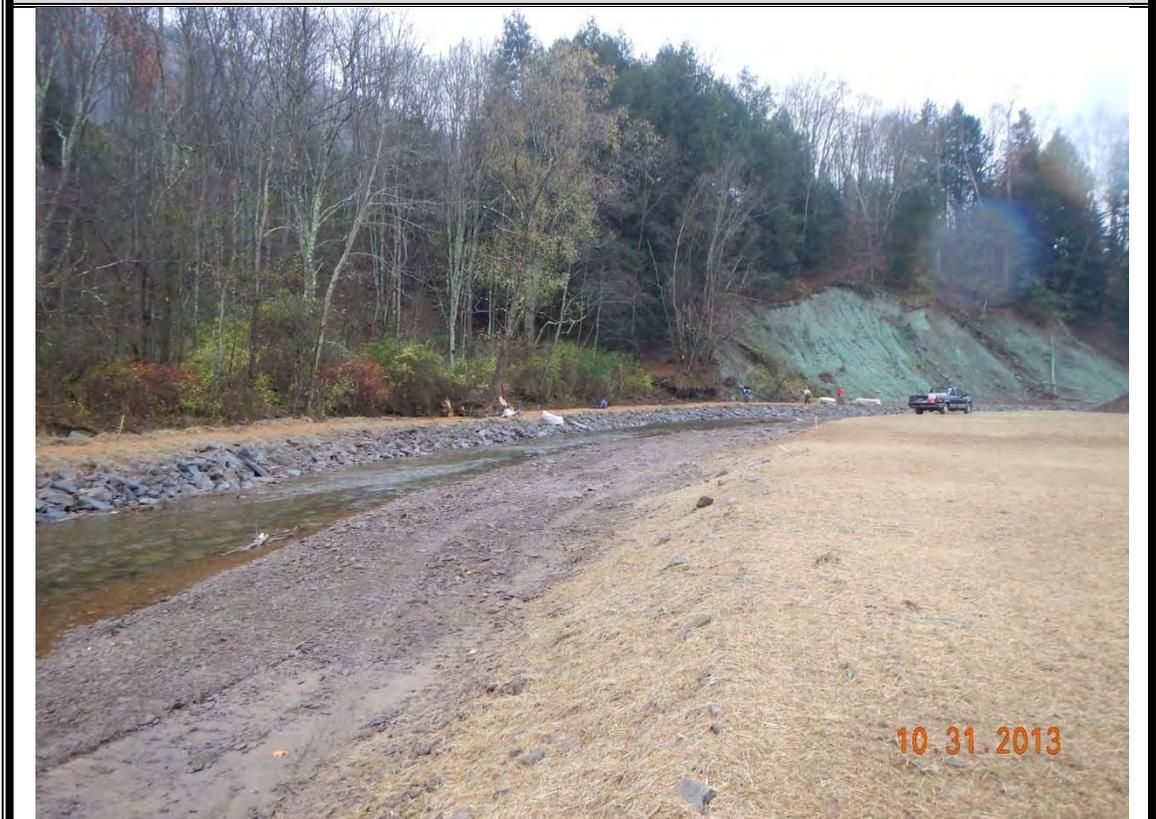
Photo 4: Looking downstream after construction of bench along left streambank, stream channel to appropriate channel dimensions and right floodplain.

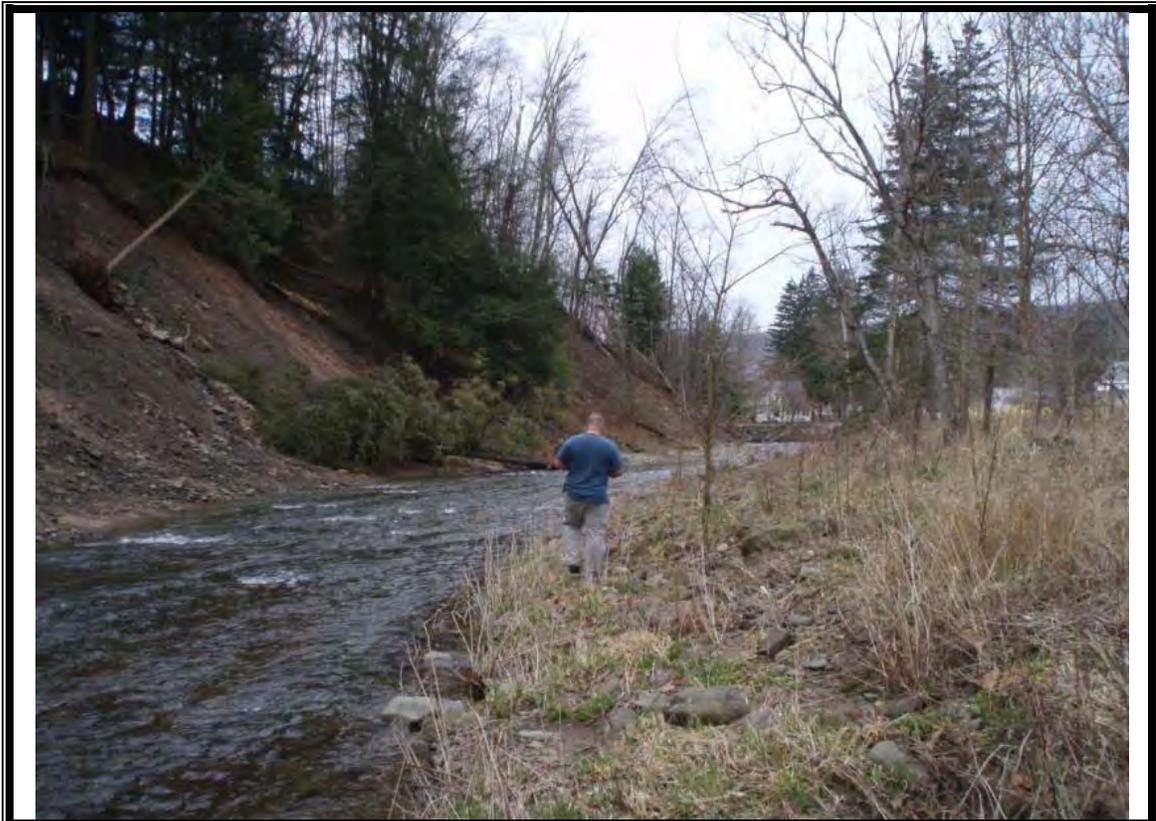
Photo 5: Looking downstream from right streambank at lower portion of project area towards the Village of Walton.

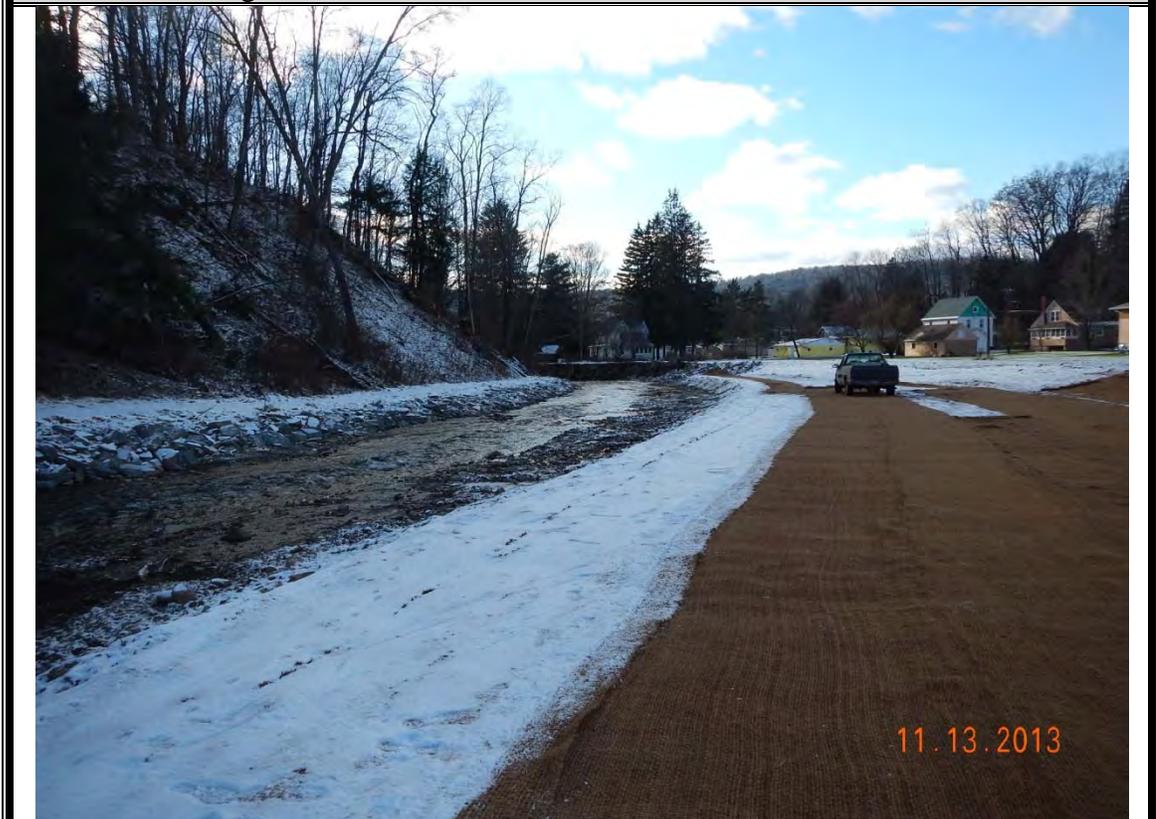
Photo 6: Looking downstream from right streambank after construction of left bench with rip rap toe and floodplain on right streambank with erosion control material.
