EWP Streambank Protection at Gosper Road Project Site
Before and After Photos

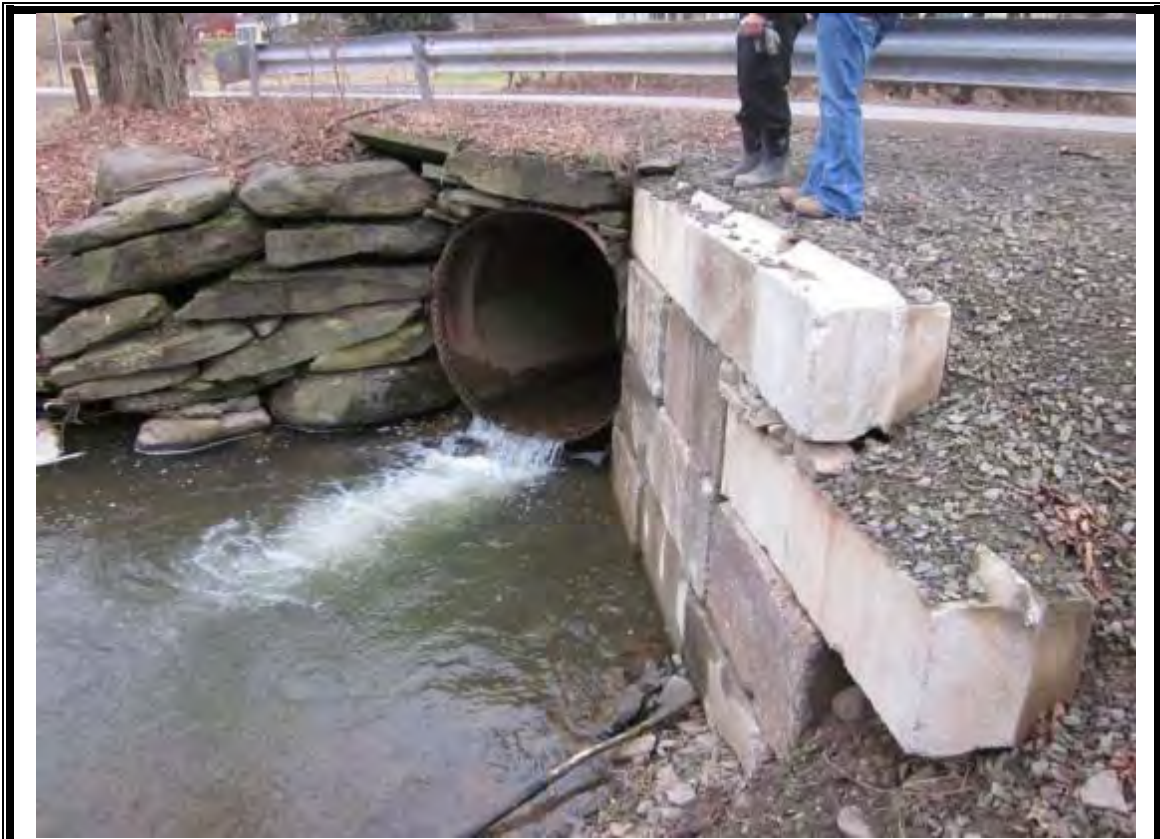
Photo 1: Looking upstream from left streambank at culvert outfall and failing head walls.

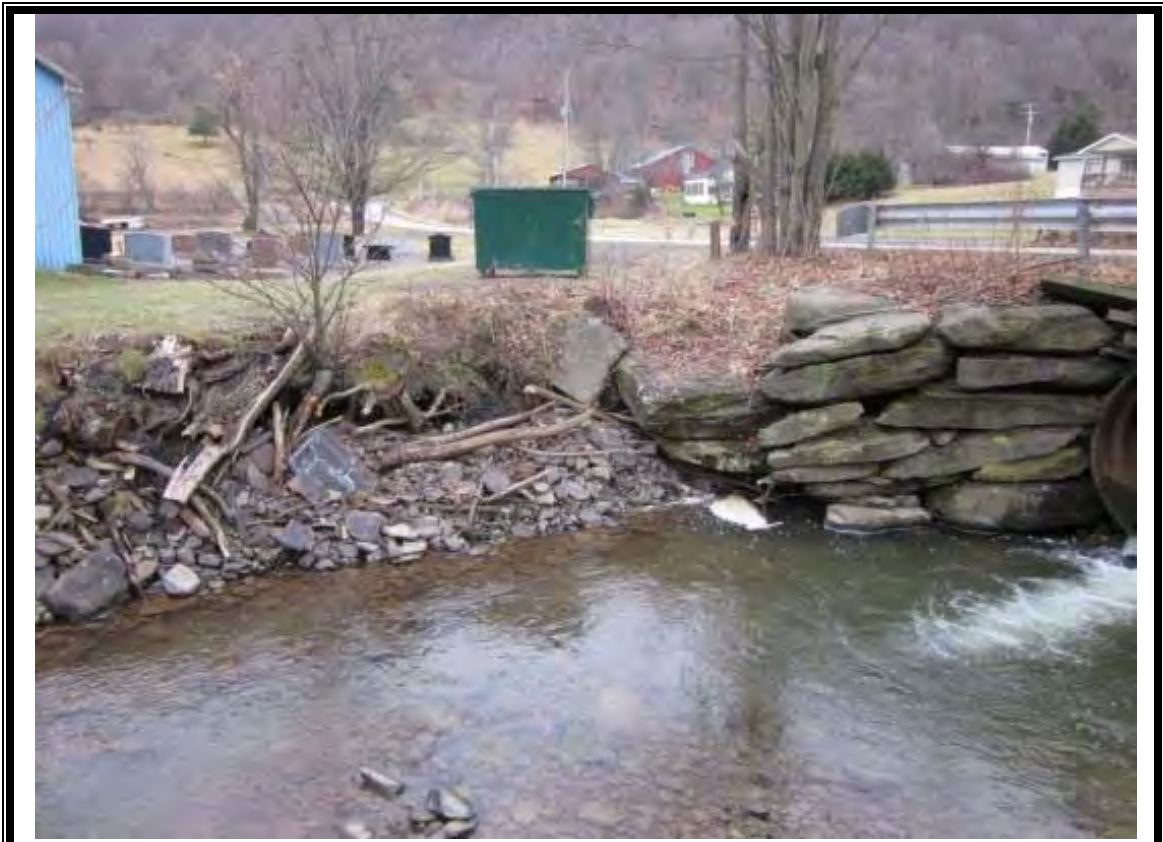
Photo 3: Looking upstream from left streambank at culvert outfall and failing head walls.
