Town of Walton Streambank Stabilization at Beers Brook Site A
Before and After Photos

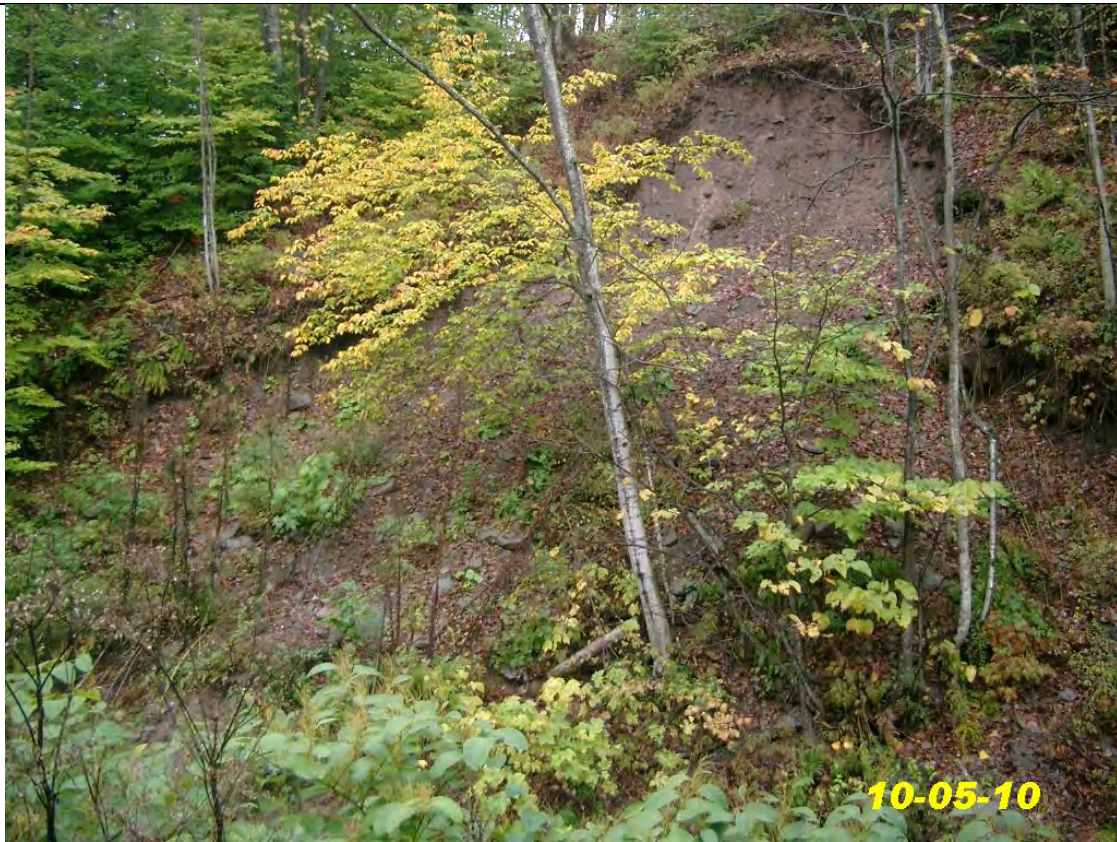
Photo 1: Looking at right streambank erosion from Beers Brook Road.

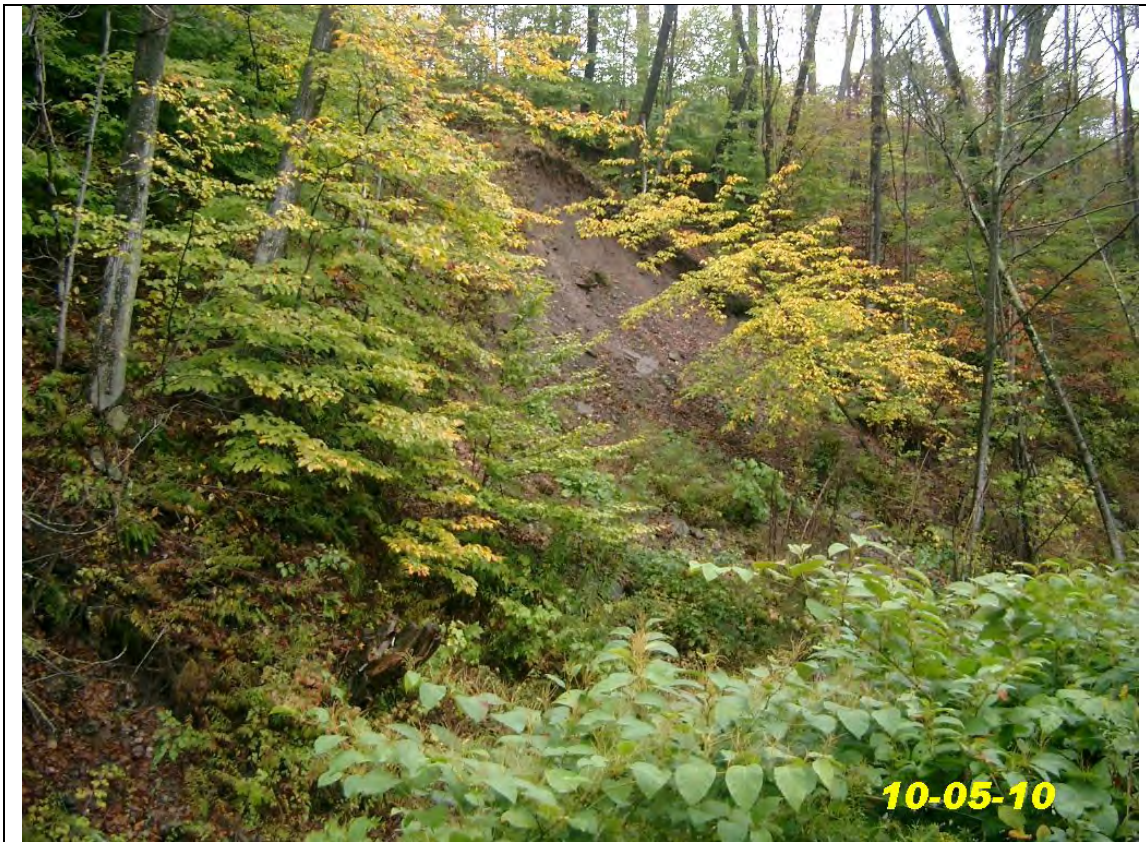
Photo 3: Looking upstream at right streambank erosion from Beers Brook Road.

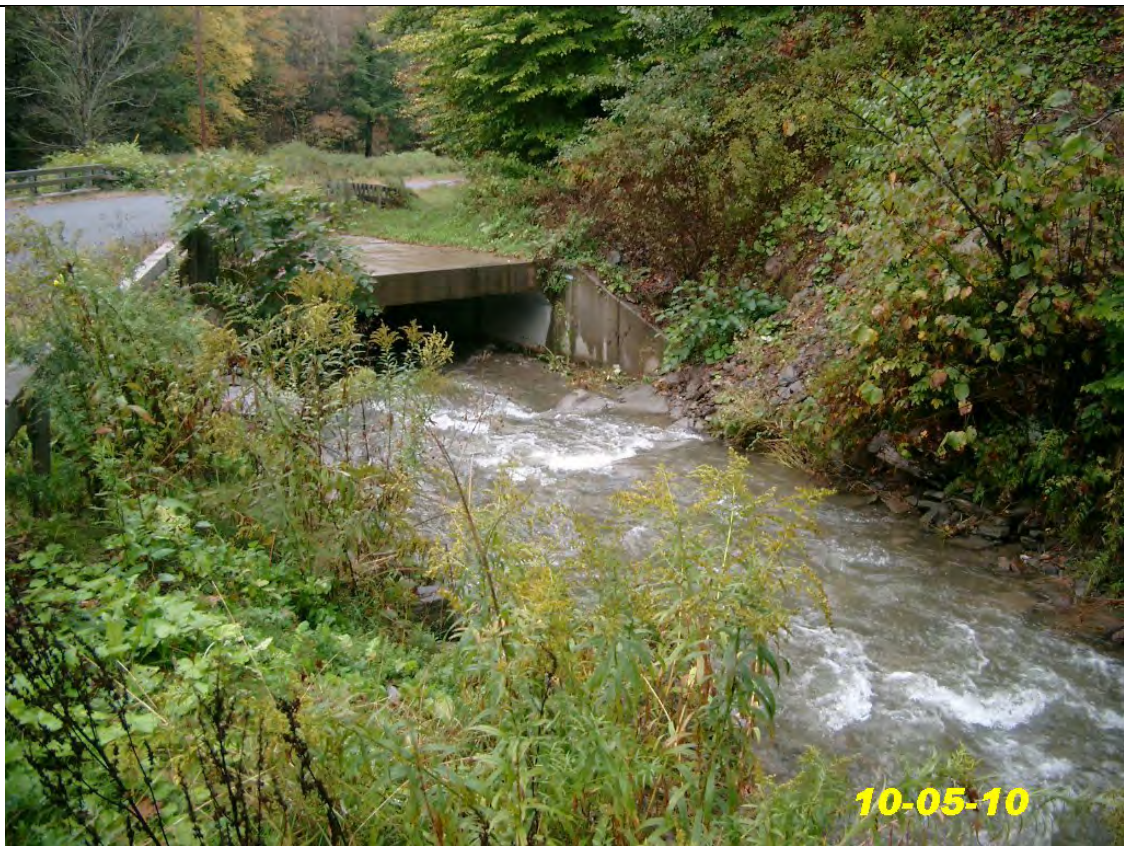
Photo 5: Looking downstream at culvert at lower end of project area.
