EWP Streambank Protection at MacGibbon Hollow Project Sites  
Before and After Photos

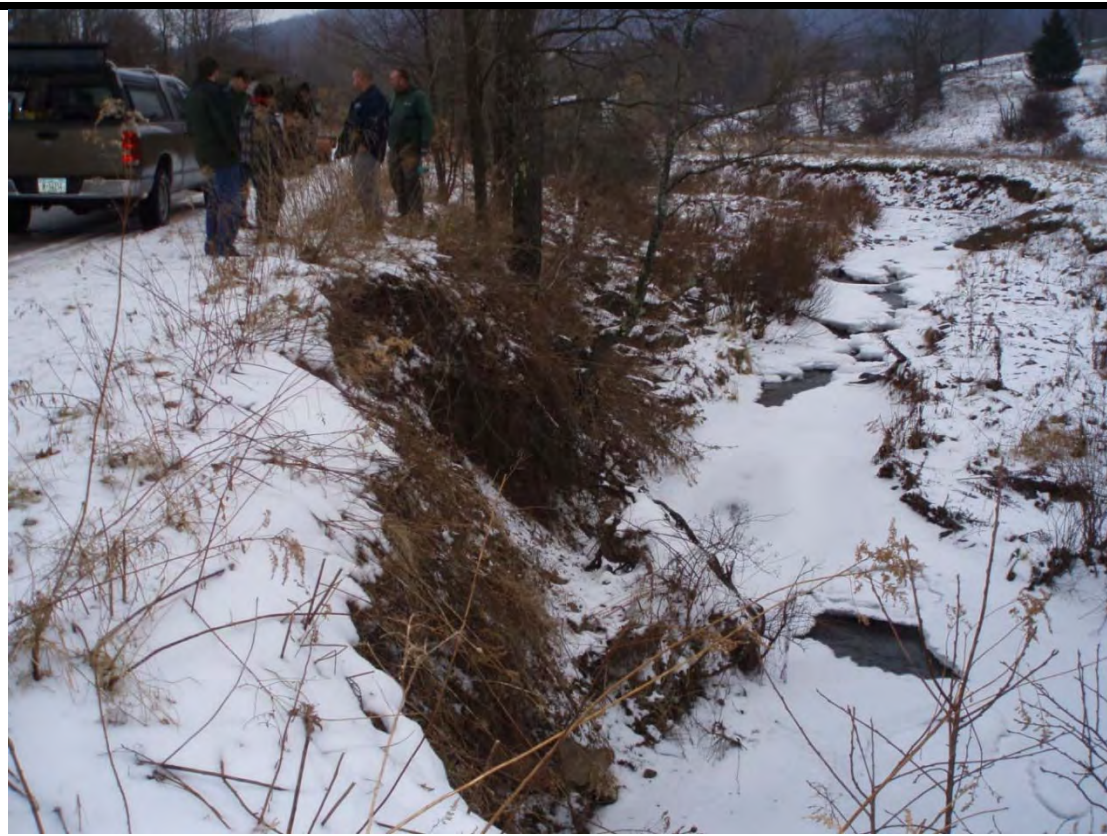
**Photo 1:** Looking upstream from right streambank at Site A and eroding streambank.

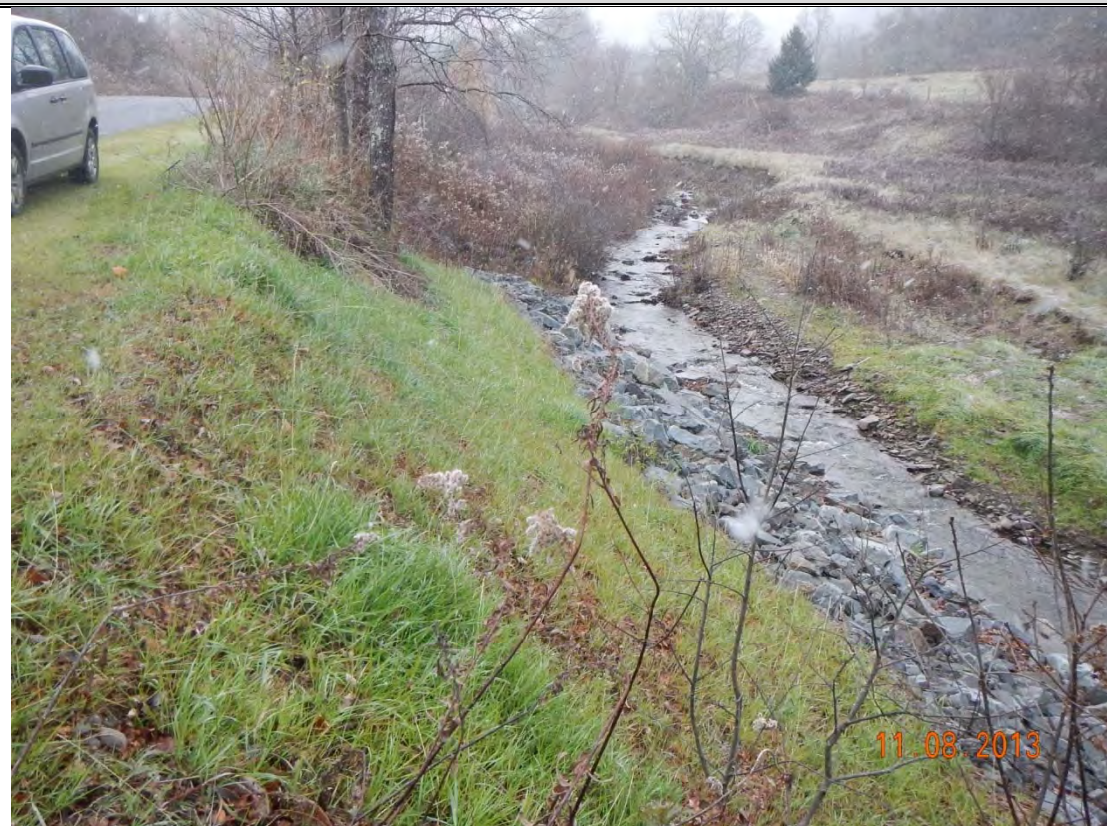
**Photo 2:** Looking upstream from MacGibbon Hollow Road after construction of rip rap along the streambank and floodplain on the left streambank.

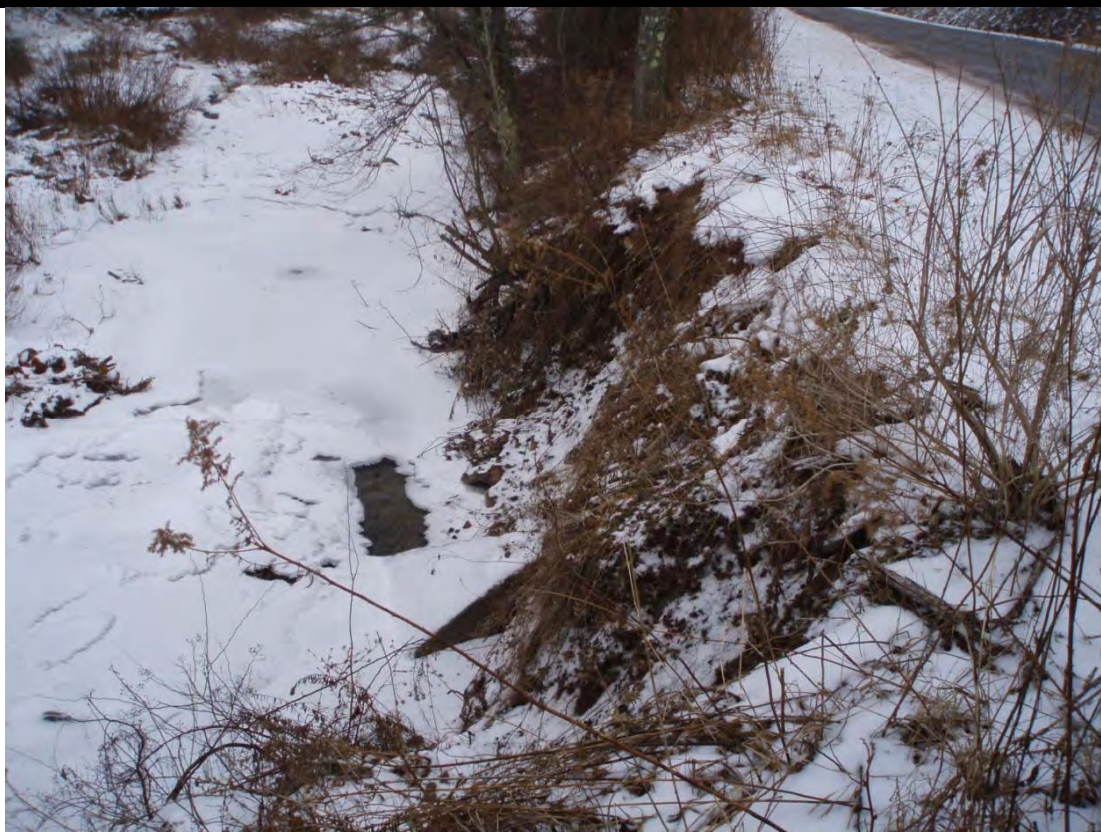
**Photo 3:** Looking downstream from right streambank at the streambank erosion along MacGibbon Hollow Road.

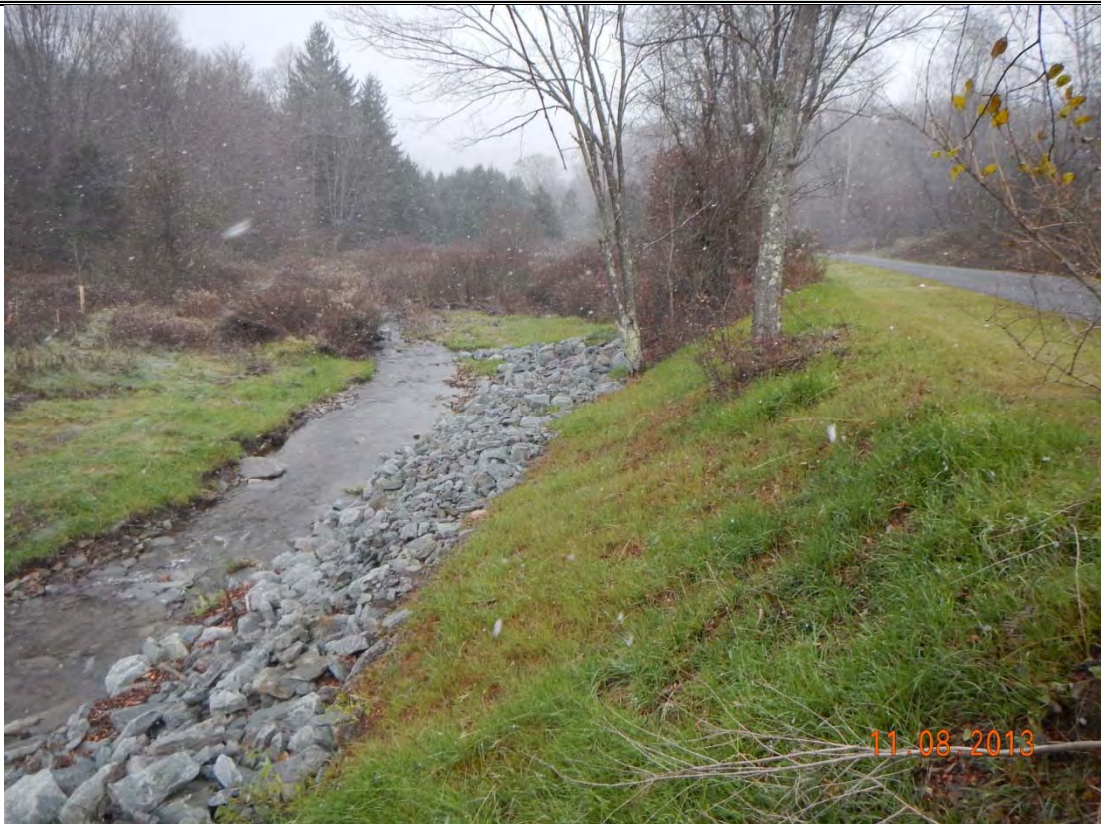
**Photo 4:** Looking downstream from right streambank after construction of rock rip rap along the streambank.

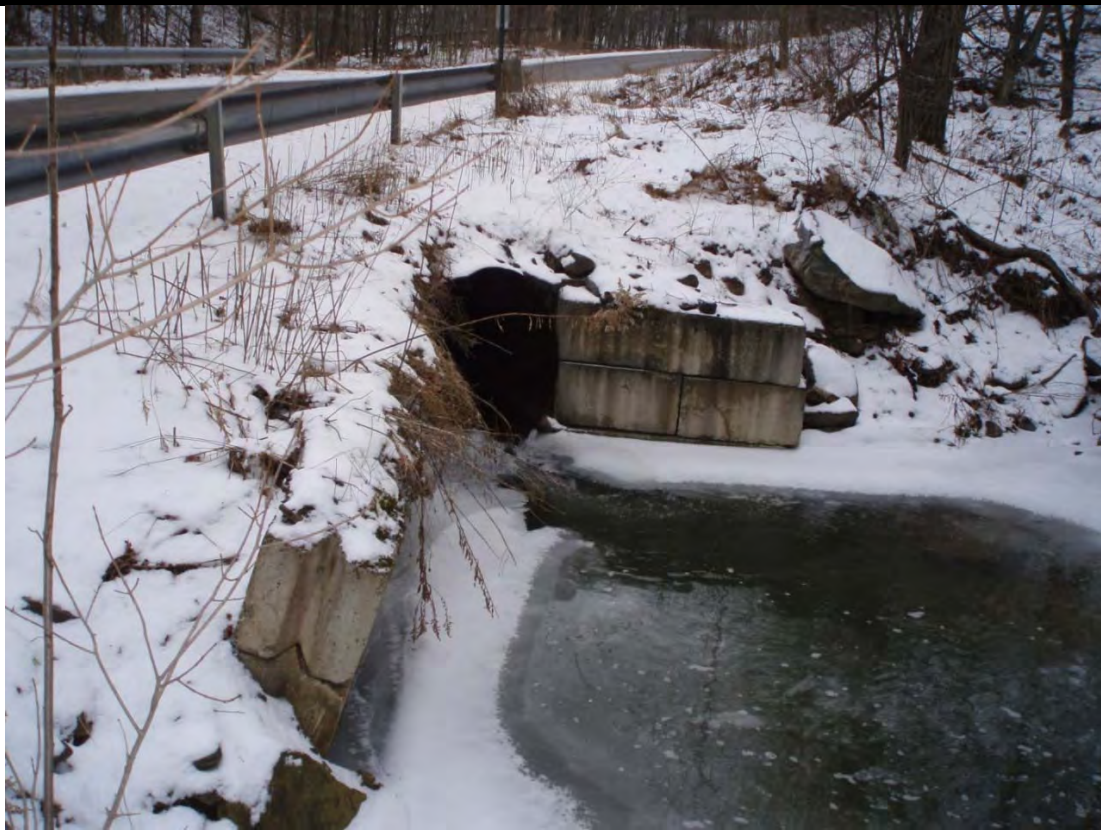
**Photo 5:** Looking at culvert along MacGibbon Hollow Road with headwalls that are failing.

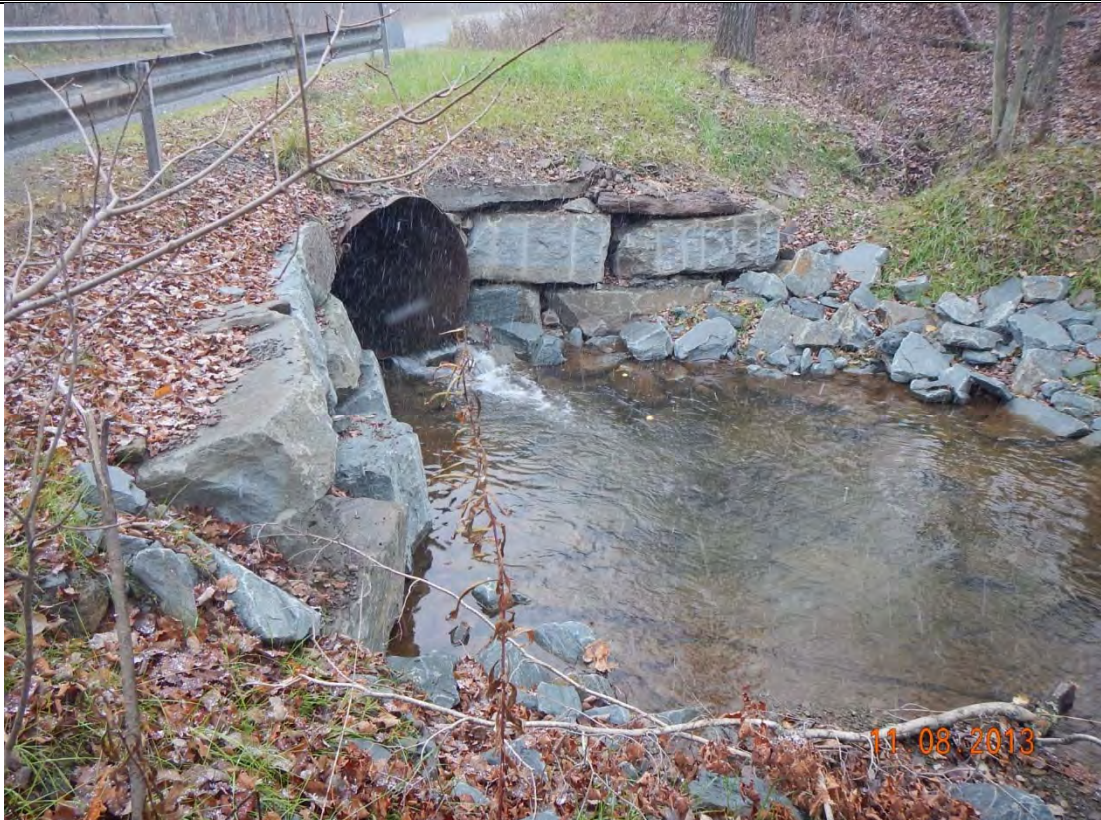
**Photo 6:** Looking at culvert after construction of stacked stone headwalls.

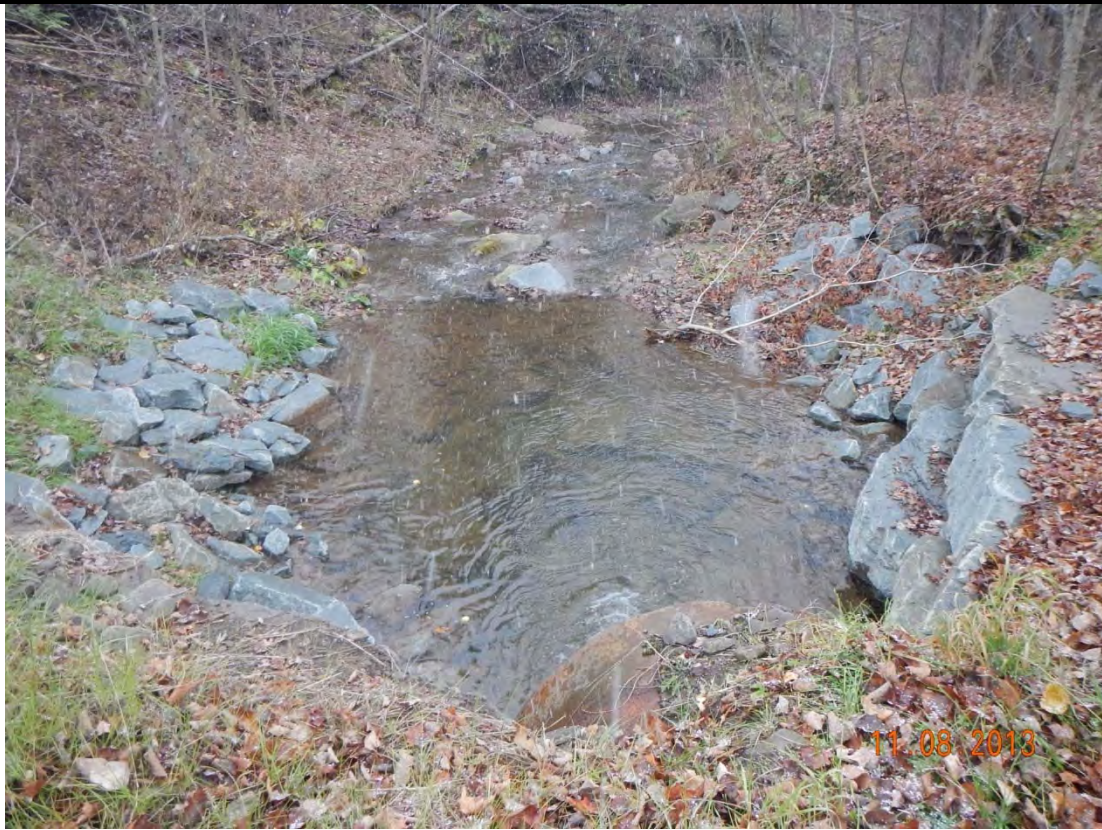
**Photo 7:** Looking downstream from MacGibbon Hollow culvert after construction of stacked rock headwalls.

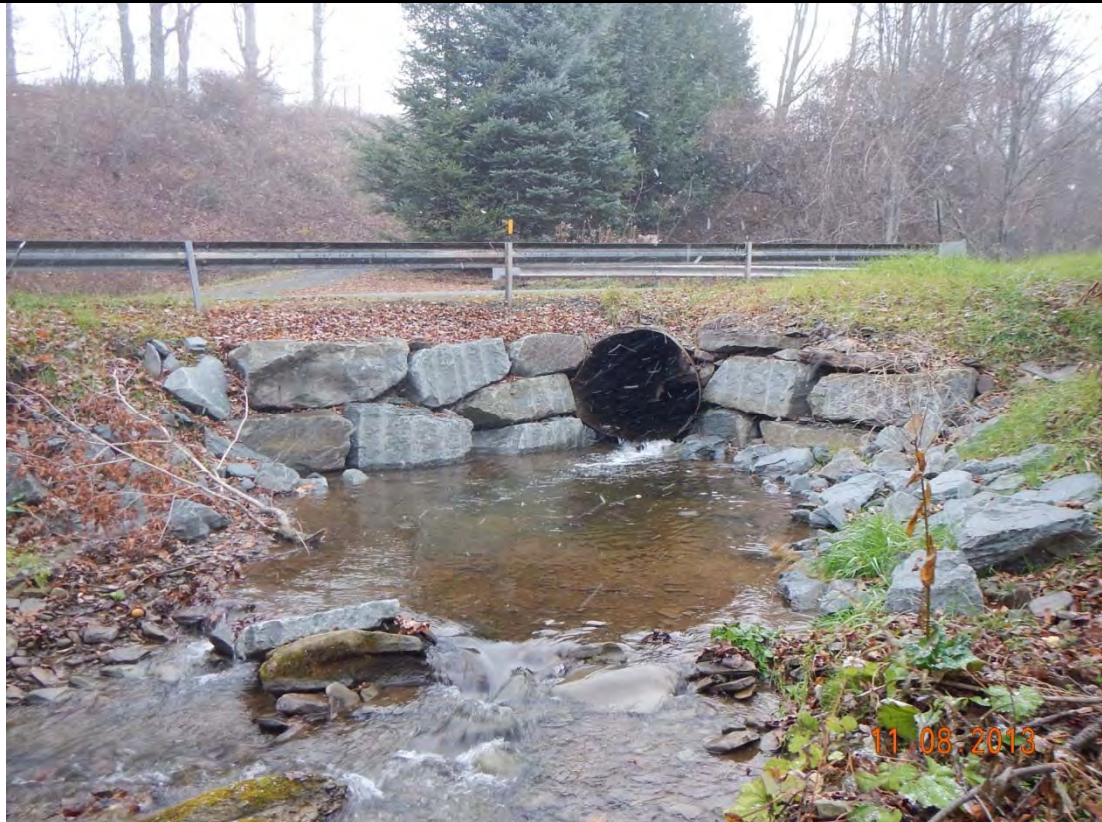
**Photo 8:** Looking upstream from MacGibbon Hollow culvert after construction of stacked rock headwalls.

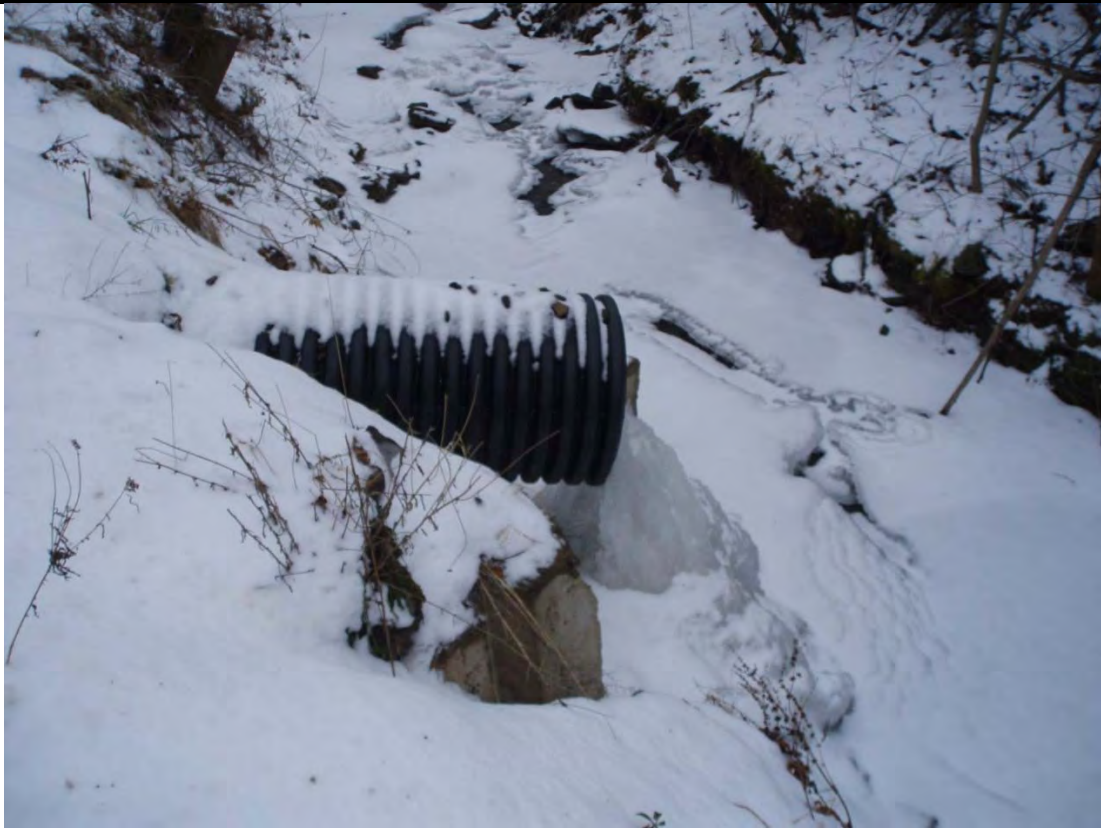
**Photo 9:** Looking upstream from right streambank at Site C and culvert outlet causing erosion.

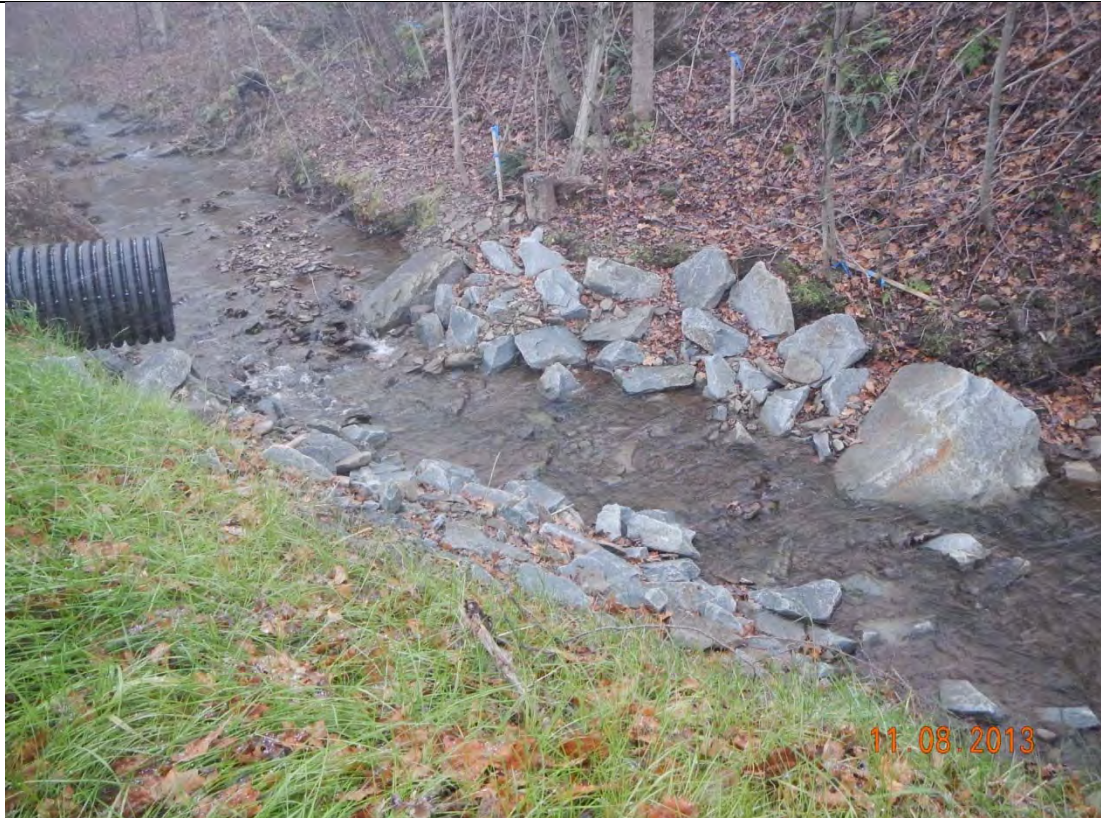
**Photo 10:** Looking upstream from right streambank after construction of culvert outfall protection and hardened riffle structure.

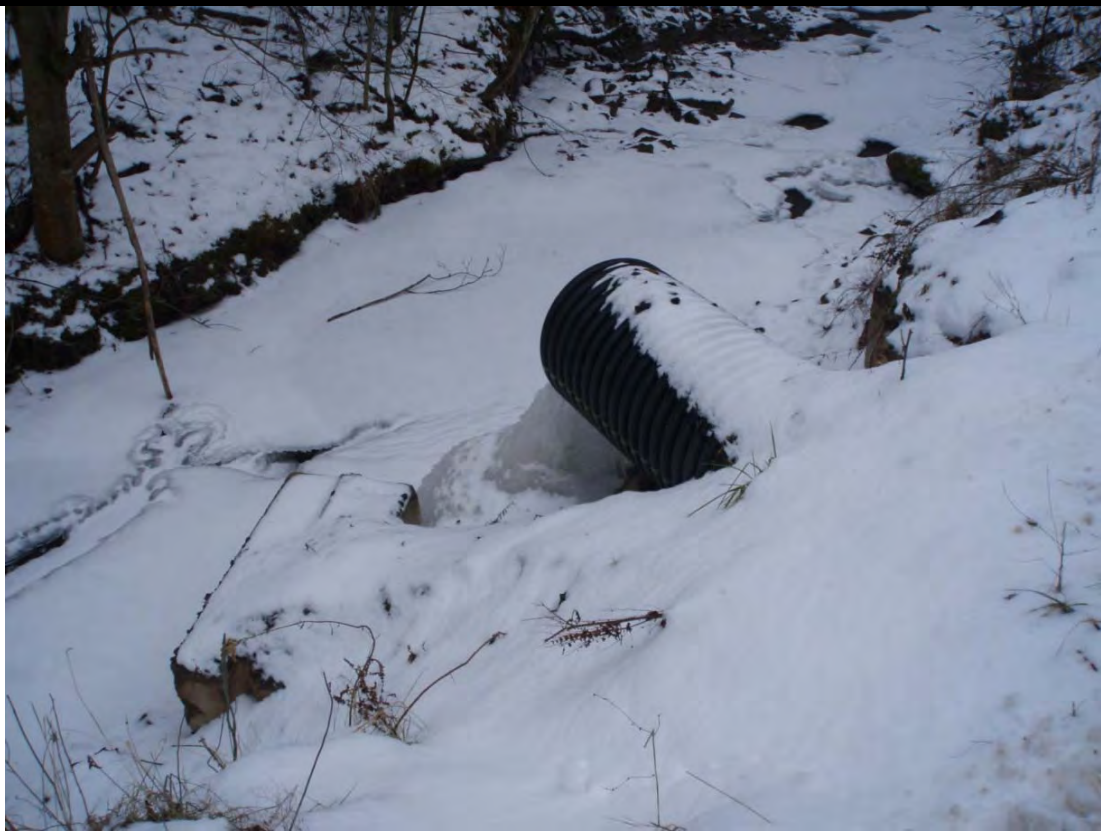
**Photo 11:** Looking downstream from right streambank at Site C and culvert outlet causing erosion.

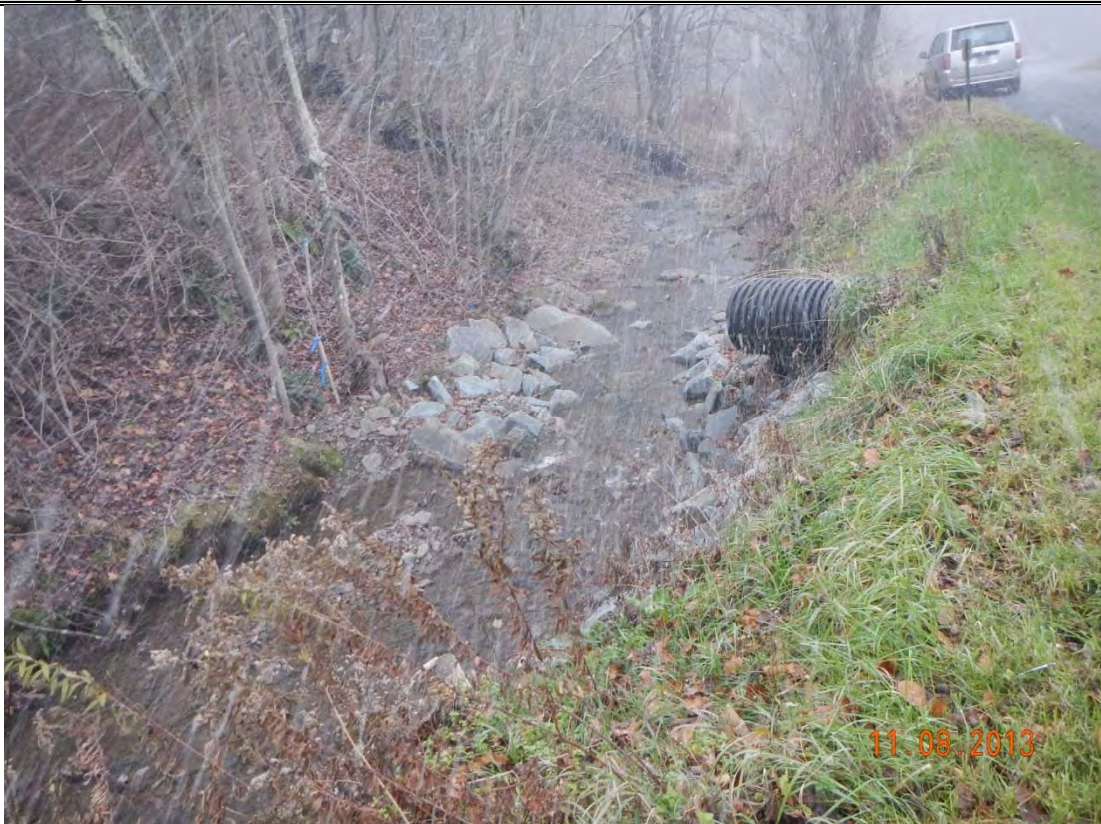
**Photo 12:** Looking downstream from right streambank after construction of culvert outfall protection and hardened riffle structure.

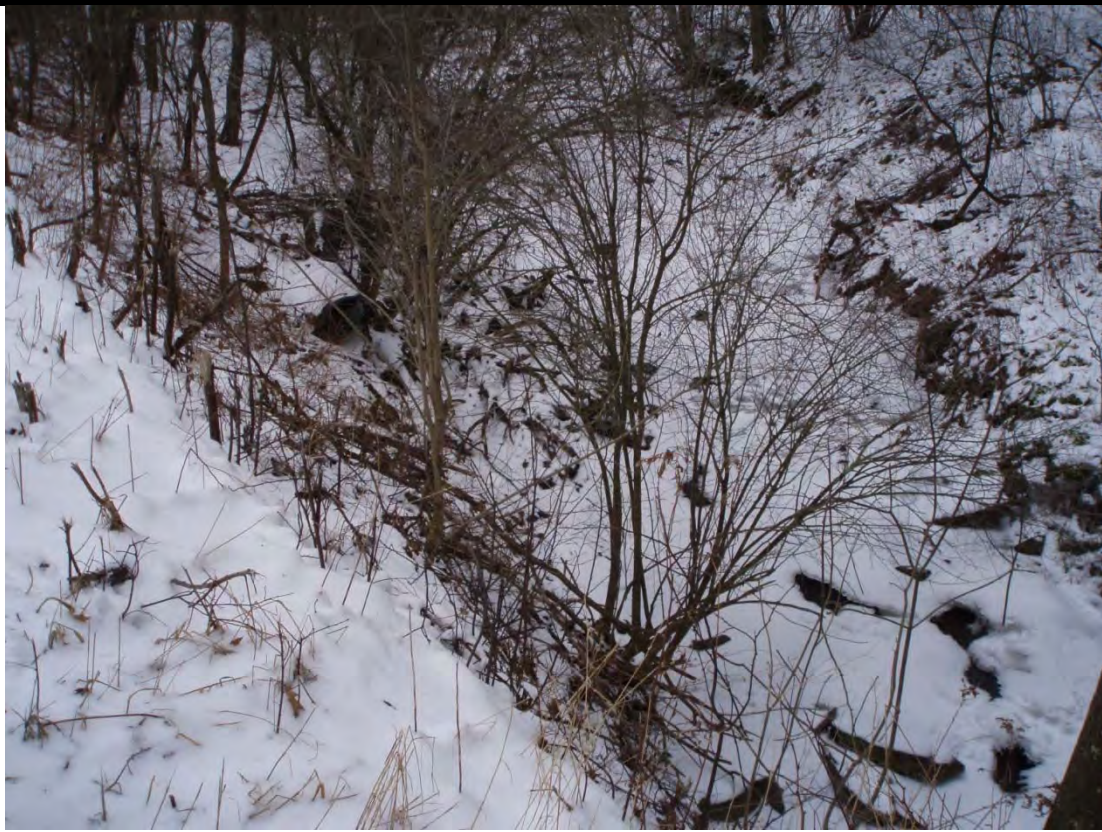
**Photo 13:** Looking upstream from right streambank at Site D and erosion along town highway.

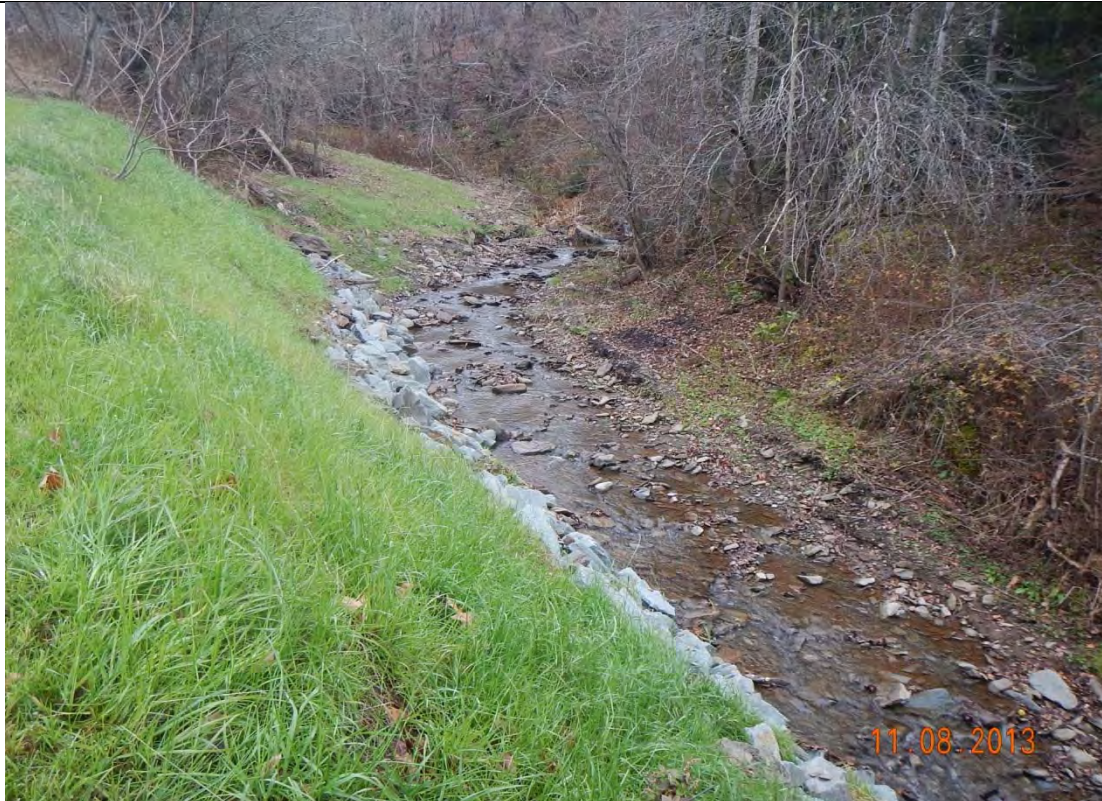
**Photo 14:** Looking upstream from right streambank after construction of rock rip rap.

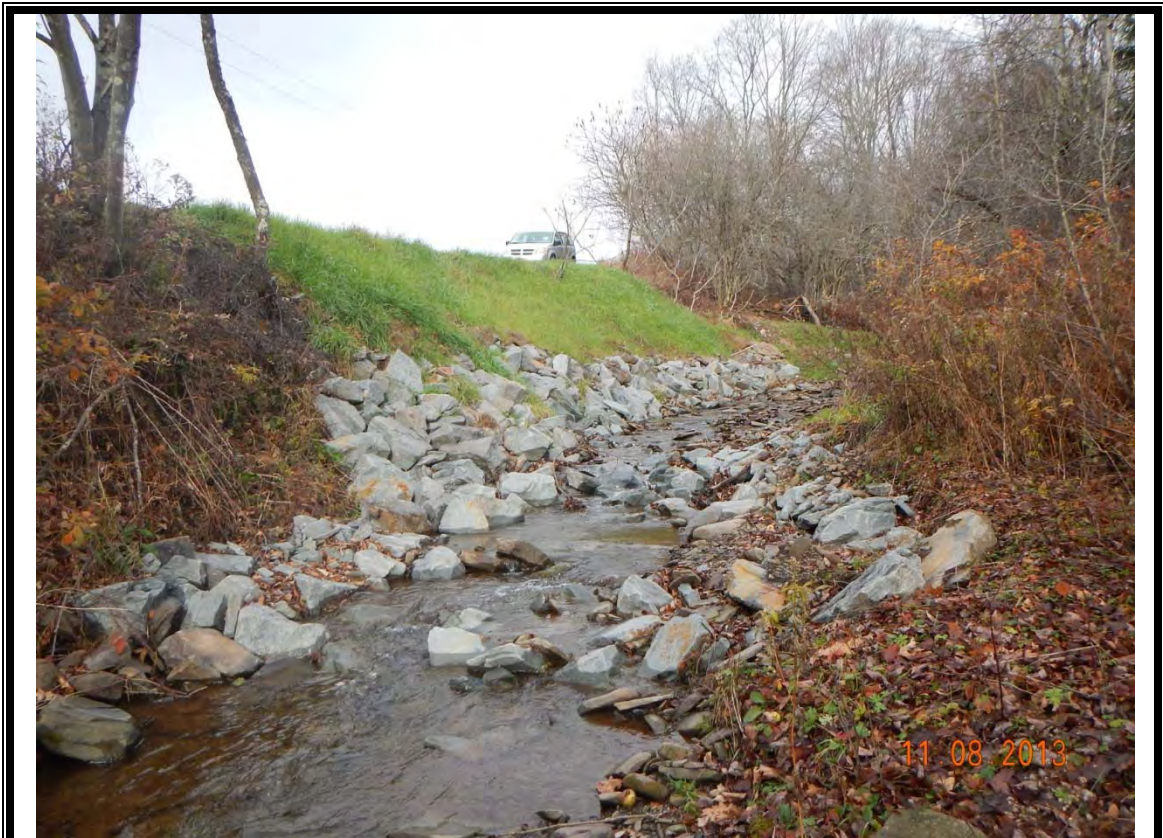
**Photo 15:** Looking upstream from left streambank after construction of rock rip rap and hardened riffle structure.

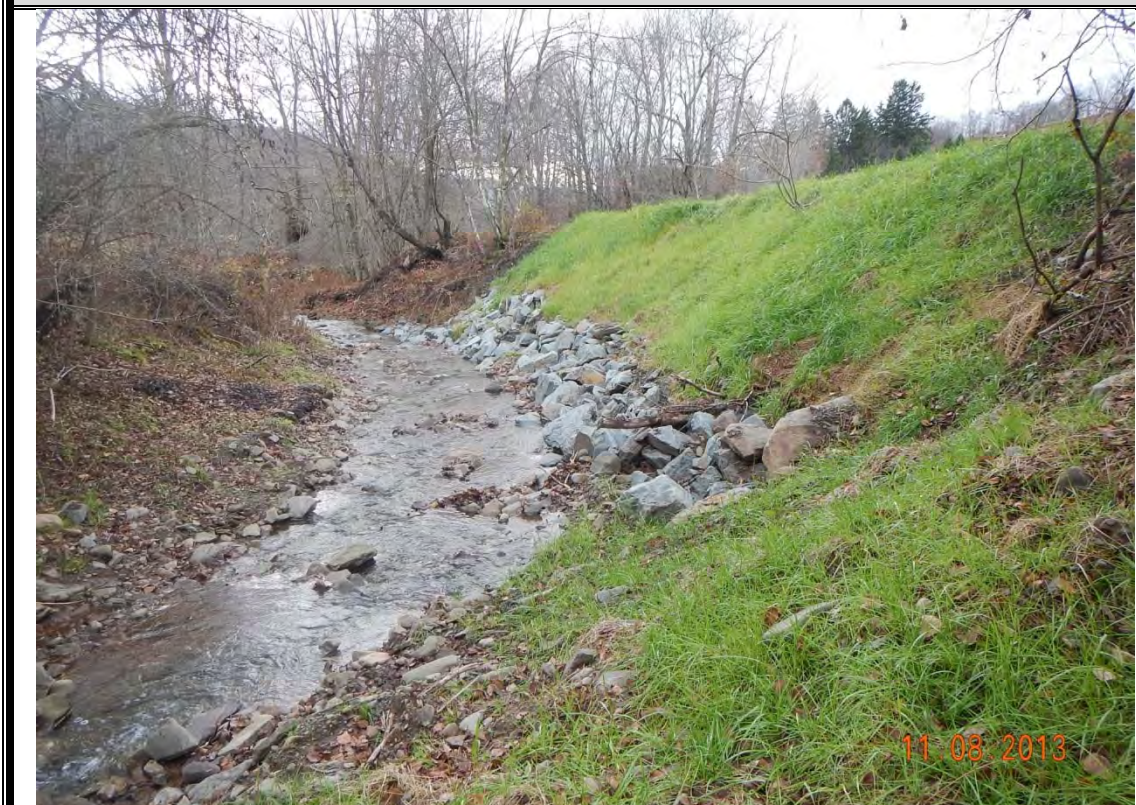
**Photo 16:** Looking downstream from right streambank after construction of rock rip rap.
