Third Brook Sites 3, 4, 5, & 6
Bank Restoration and Stabilization Project
Before and After Photos

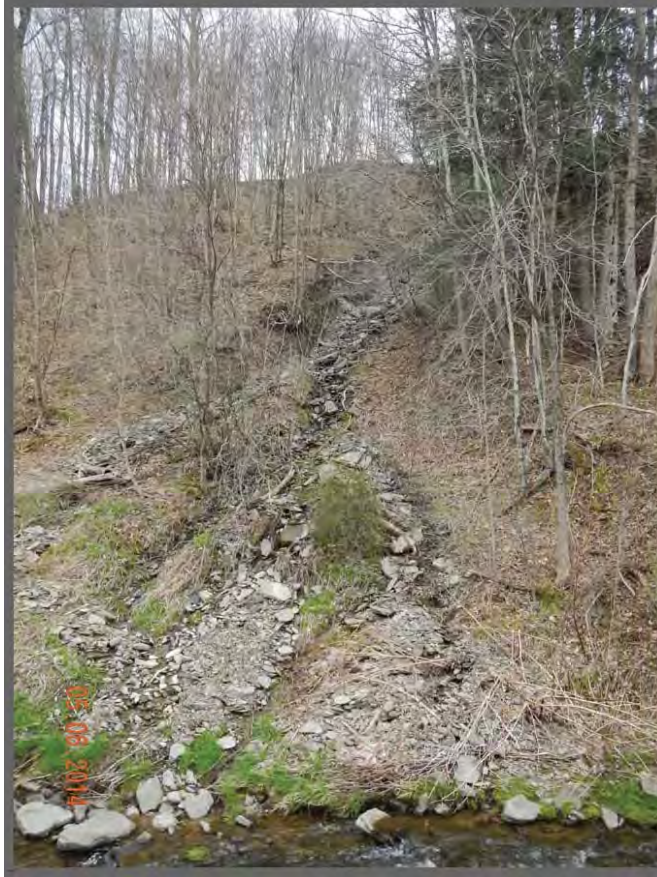
Photo 1: Looking at right streambank at lower portion of Site #3.

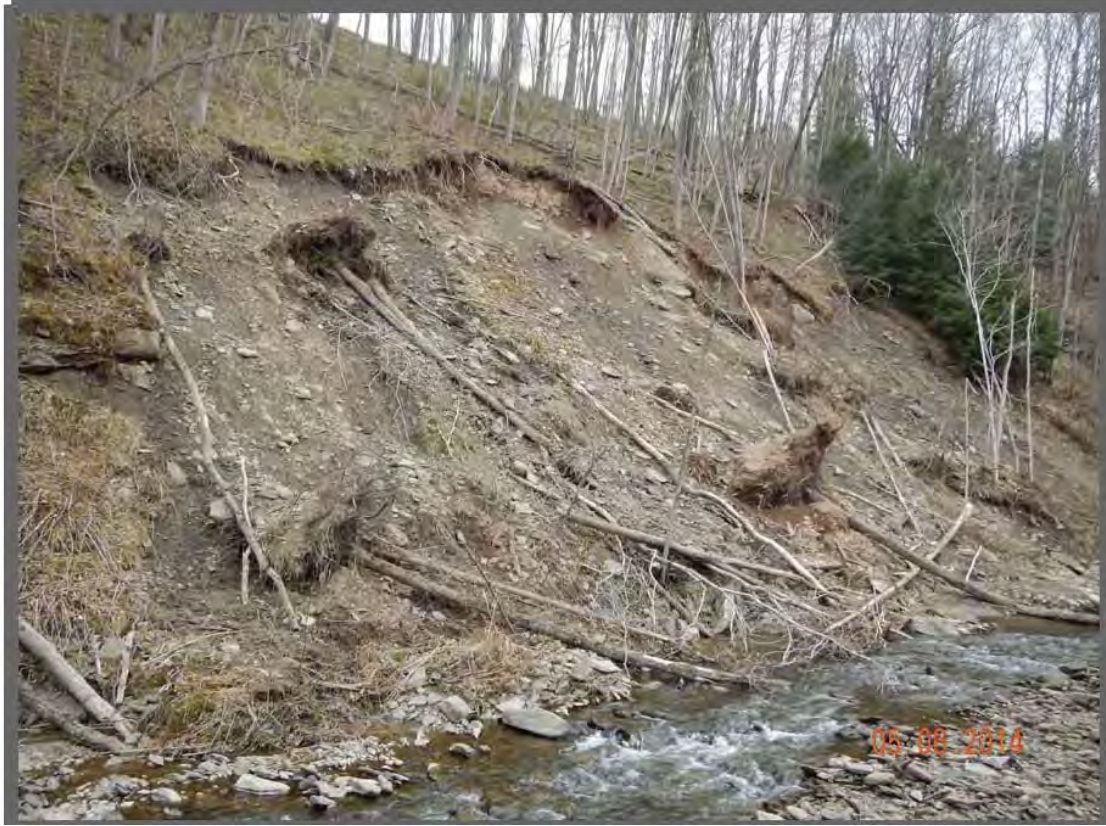
Photo 3: Looking upstream at the middle section of Site #3.

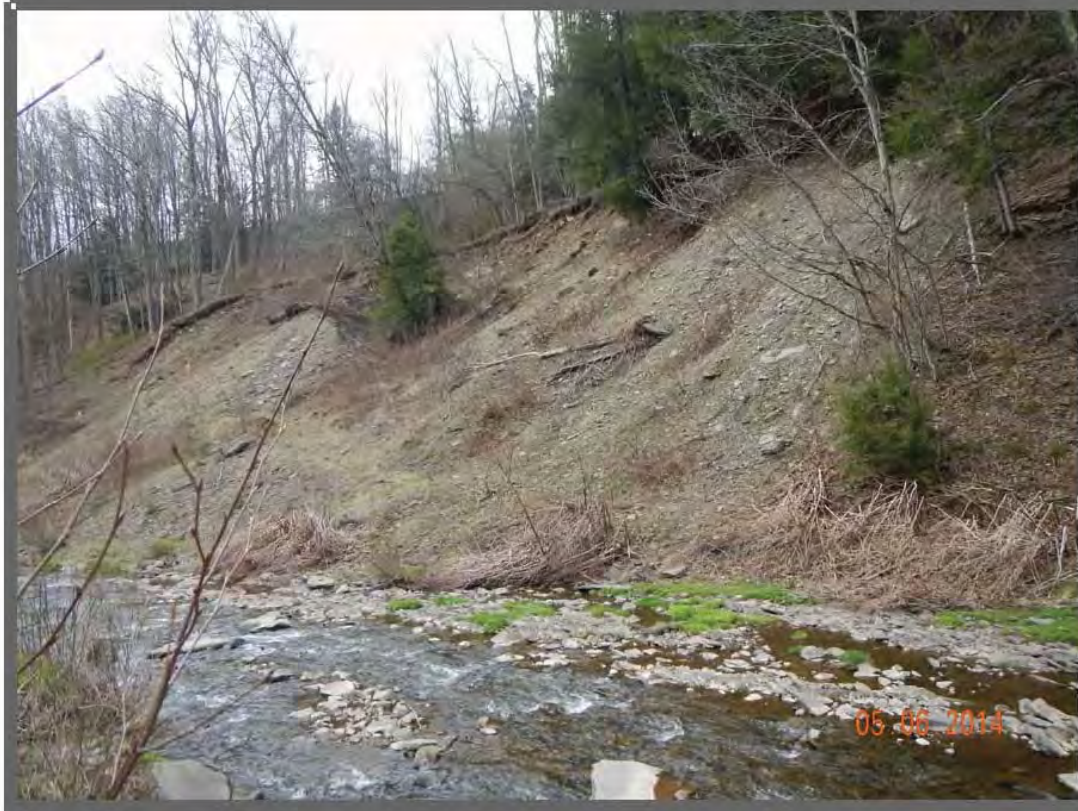
Photo 5: Looking downstream at right eroding streambank at Site #4

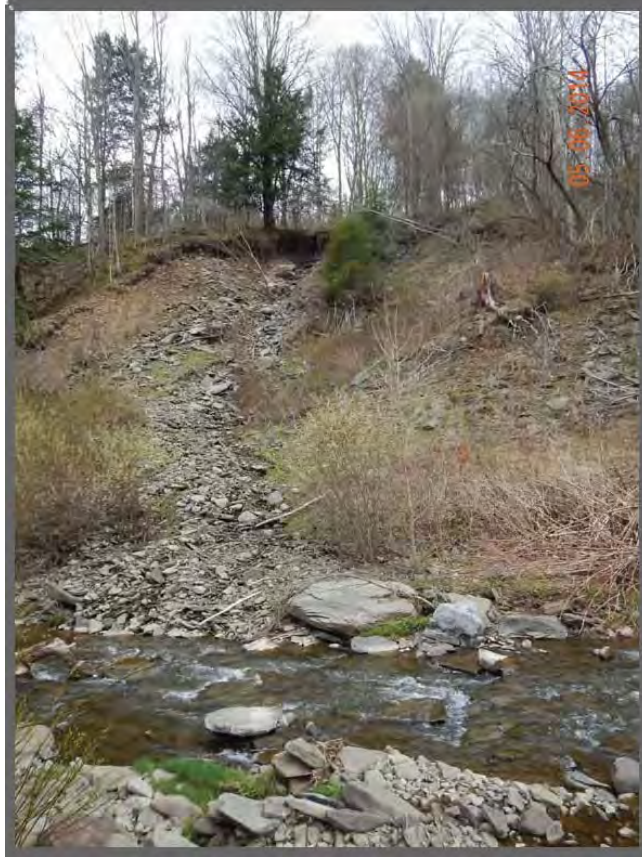
Photo 7: Looking downstream at right eroding streambank at Site #5.

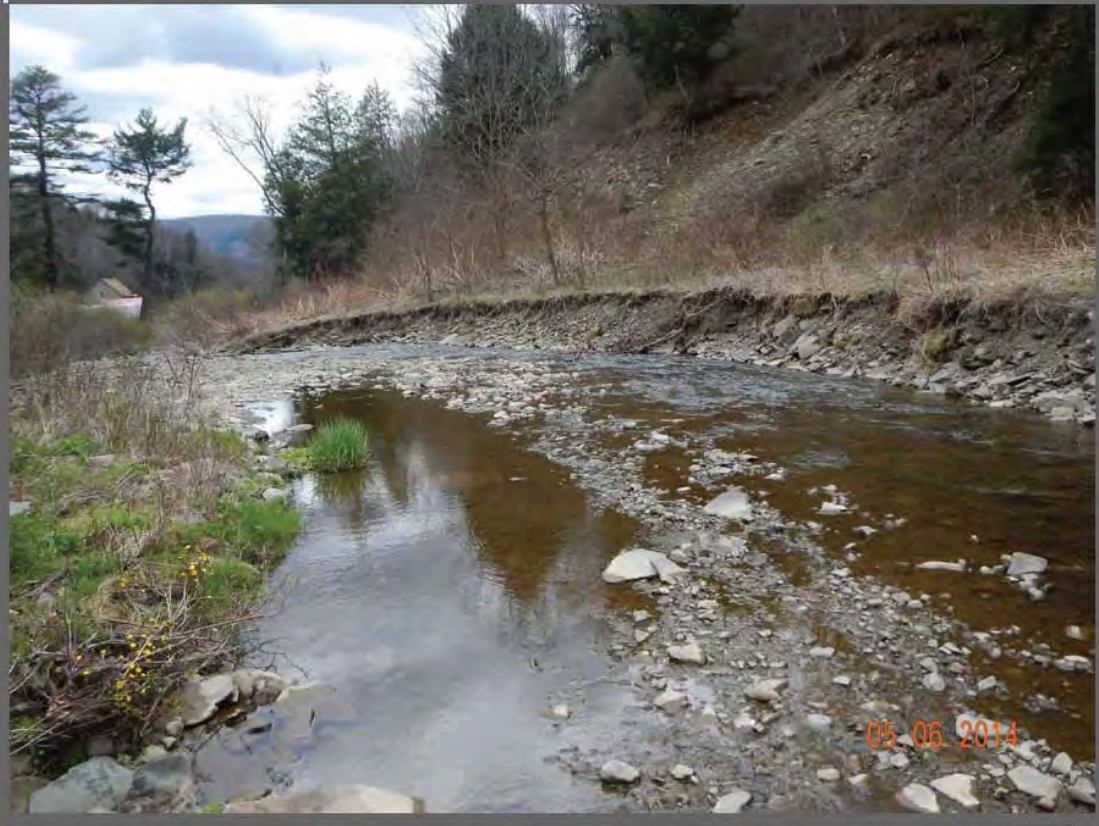
Photo 9: Looking downstream at right eroding streambank at Site #6.
